Certificate of Completion

Duct Sealing performed for
9105 Edinburg Lane

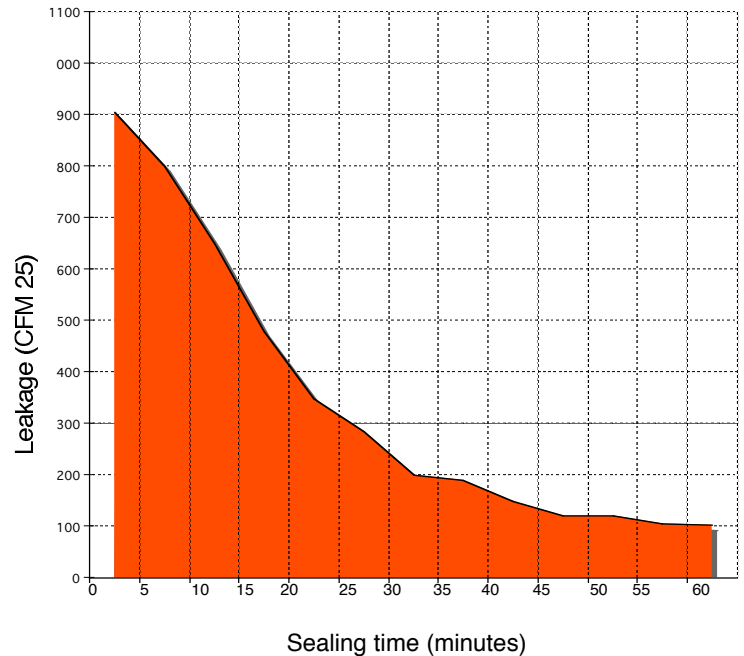
Aeroseal Sealing Profile

When we arrived, your ducts had:
937 CFM of leakage,
equivalent to a
178 square inch hole

After we finished, your ducts had:
54 CFM of leakage,
equivalent to a
10 square inch hole

**Results in a
94% Reduction
in duct leakage**

Note: duct leakage results are calculated in cubic feet per minute (CFM) measured at a standard reference pressure of 25 pa (.10 inches of water)

Your heating and cooling capacity improvement for duct sealing is 52% based upon measured leakage reduction and original register flow.
